Use of Coatings on Hydraulic Steel Structures

Part 1-Overview and Field Survey

ERDC/CHL CHETN-IX-43 September 2016

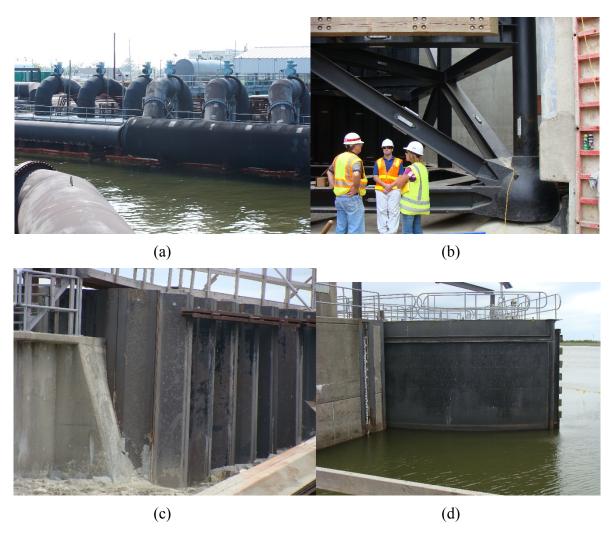
Figure 1. Examples of coal tar coating: (a) pumping station; (b) sector gate; (c) sheet piles; and (d) sector gate in brackish water.

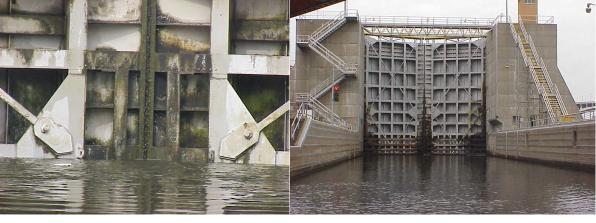
Figure 2. Examples of vinyl coating. (a) Tainter and roller gates on the Mississippi; (b) 50-year-old vinyl on miter gate; and (c) closure gate in New Orleans.
